Case Study

Solvent Spillage Emergency Response,
using Sustainable Thermally Enhanced
Degradation

Steam Enhanced Extraction Dichloromethane Emergency Response—ERM

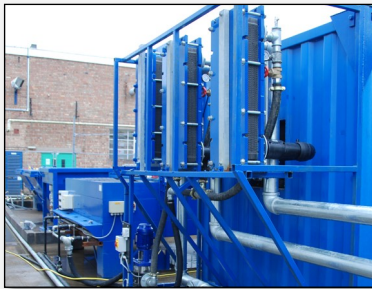
Remediation System

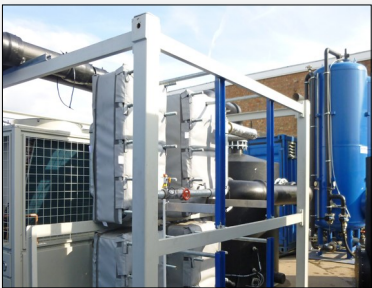
Heat Exchangers
